MICROSTRUCTURAL CHARACTERIZATION OF PRIMARY WATER STRESS-CORROSION CRACKS IN ALLOY 182 WELDS FROM PWR COMPONENTS AND LABORATORY TESTS

L.E. Thomas, M.J. Olszta, B.R. Johnson and S.M. Bruemmer

Pacific Northwest National Laboratory, PO Box 999, Richland, WA, 99354, larry.thomas@pnl.gov

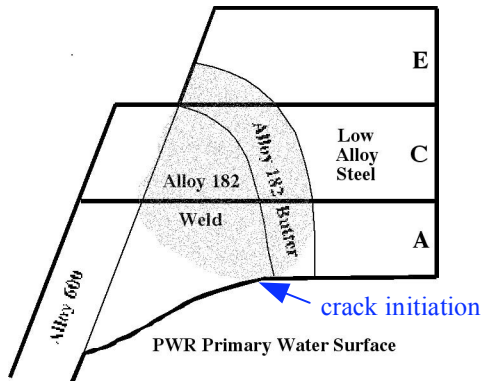
The North Anna 2 sample came from a control rod drive mechanism (CRDM), Nozzle 31, with cracks in the alloy 182 J-weld joining an alloy 600 penetration pipe to the low-alloy pressure vessel steel. Figure 1 schematically illustrates the nozzle structure and crack location. Metallographic examinations of sections cut from the nozzle showed that multiple cracks had initiated from the primary-water surface of the weld and propagated axially to intersect both the alloy 600 and the pressure vessel steel. The cracks also reached the air gap between the pressure vessel steel and the alloy 600 pipe.

Figure 1. Axial crack location (shaded) in weld from North Anna-2 Nozzle 31. Letters refer to metallographic sections.

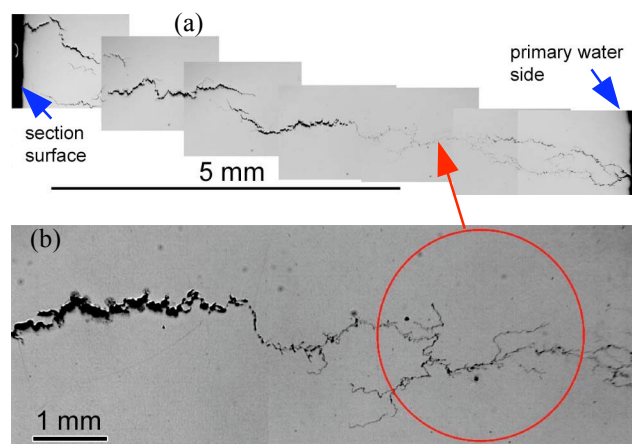
Metallographic examinations of polished sections from the North-Anna-2 J-groove weld showed that multiple cracks had initiated at the primary-water surface in the weld butter region, and had propagated through the weld metal to intersect both the alloy 600 and the pressure vessel steel. Figure 4 gives a low-magnification view of the cracks and a detail view of one region that was

targeted for TEM sample preparation. The periodically segmented appearance of the crack in this section may reflect the weld structure or stresses, although this is not known for certain. Relatively wide crack openings suggested that the cracks had opened under high stresses. Despite the appearance of discontinuous cracks on cross sections, the presence of corrosion products throughout the cracks indicated an interconnected crack network that had been fully penetrated by high-temperature water.

The metallographic examinations also showed that the cracks coincided with grain boundaries in the weld metal. These boundaries had a characteristically wavy, serpentine appearance reflecting formation by dendrite impingement during solidification. Apart from minor occurrences of grain-boundary migration, the boundaries where cracking occurred were both crystallographic grain boundaries and interdendritic boundaries.

Figure 4. Optical micrographs of North Anna CRDM cross section showing main crack running through entire section thickness. Scale marker length 5 mm. Circle in lower figure represents size of 3-mm-diameter TEM disk.

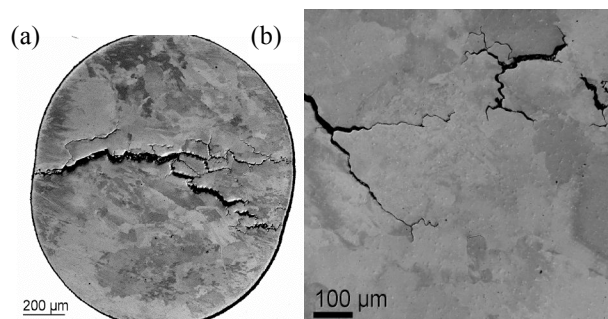
Since the crack traversed the entire width of the section and thus did not contain a unique primary tip, TEM samples were prepared from the middle of the section. Extensive crack branching yielded many secondary tips that were suitable for ATEM. SEM/BSE images of a TEM sample, shown in Figure 5, further illustrate the appearance of the cracks and their relation to grain boundaries. The mottled crystallographic contrast of the grain images is characteristic of strained material. Zooming in on the higher magnification micrograph in Figure 5 reveals scattered 0.2- to 1- μ m-diameter second-phase particles throughout the grains and along the grain boundaries the white-appearing particles are predominantly Nb carbides and the dark particles were mainly TiC. As shown later, the grain boundaries were heavily decorated by fine NbTi carbide and Cr-carbide particles. These smaller particles were generally too small to observe at the relatively low magnifications of the SEM.

Figure 5. SEM/BSE images of TEM samples prepared from crack area North Anna 2 CRDM weld. Taken from dimple-polished side with support washer after brief ion milling.

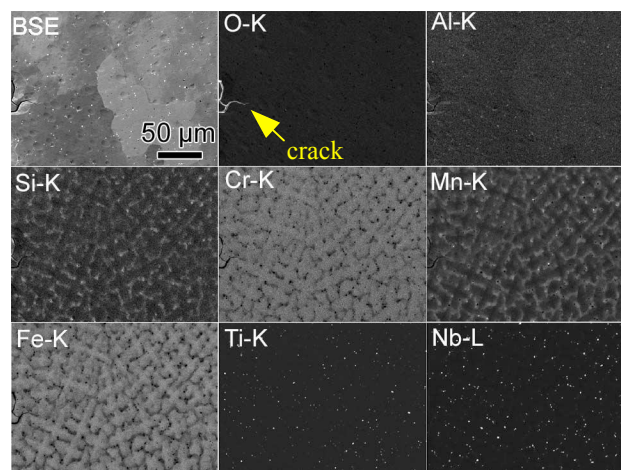
EDS maps taken in the SEM reveal the weld compositional microstructures in relation to the grain boundaries and cracks. Low-magnification maps and the corresponding BSE image shown in Figure 6 provide an overview of the weld dendritic structures. A secondary crack tip appears at the left side of the image area, and the O-K map indicates that the crack was filled with oxide. The major feature of this map set, however, is the dendritic structure revealed as patterns of constitutional segregation. The Fe-K map, in particular, clearly shows the dendritic structures of the individual grains. These compositional structures each have a regular alloy framework of Fe- and Cr-rich regions with interstitial Mn and Si-rich regions of the last-solidified material. Qualitative compositional analyses from the SEM/EDS data indicated that the high-Mn regions were enriched by ~3-5 wt%, and the high-Si regions were enriched by ~2 wt%, compared to the Fe-Cr-rich regions. The elemental maps reveal Nb, Ti, Mn, Al-rich particles.

Figure 6. SEM/EDS elemental maps showing weld segregation and precipitation in North Anna 2 sample.

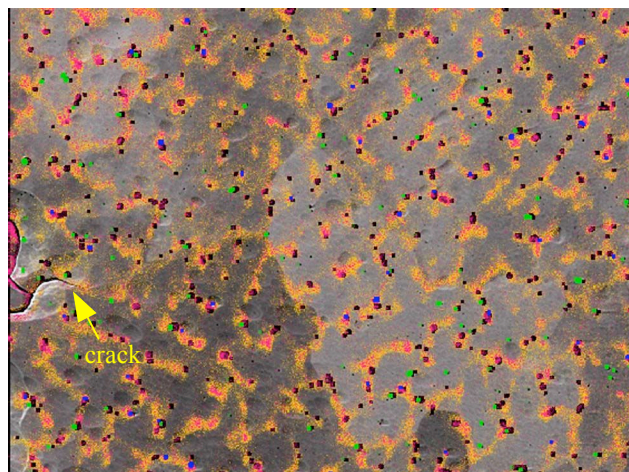
Figure 7 shows a color composite image made by combining several maps to further demonstrate important relationships between the μm -size second-phase particles, the dendrite structures, and the grain boundaries. This image is a composite of maps for Nb (black), Ti (green), high Mn (blue) and low Mn (yellow), and is superimposed on the BSE image. Blue spots in the high Mn map indicate MnS particles. (EDS point analyses were used to identify the S in the MnS particles because spectral overlap between S-K and Nb-L x-rays prevented directly mapping the S). The Nb (carbide) and MnS particles can be seen to coincide with the Mn-Si alloy regions of the dendrites. The Ti-rich particles (probably TiC or Ti(C, N)) show a weaker correlation with the dendrite segregation, usually appearing in the Mn-Si-rich regions, but sometimes also in the Fe-Cr-rich areas.

Comparing the Mn-Si-rich regions with the BSE image shows a moderate correlation of these areas with the grain boundaries. About 50% of regions along the grain boundaries coincided with high Mn and Si locations, but many others coincided with the high Fe and Cr locations. Other areas containing cracks showed a similarly weak correlation between grain boundaries and the constitutional segregation and μm -scale precipitation from the dendrites. The μm -size carbides and MnS particles produced during weld solidification appeared at approximately the same frequency along the grain boundaries as they did in the grain interiors. Further comparisons made by overlaying various elemental maps indicated no O in the intragranular particles and no correlation of the Al-rich particles with the other particles.

Figure 7. Color composite of SEM/EDS maps illustrating correlations between weld dendritic microstructure, second-phase particles and grain boundaries. color key: yellow -Mn; pink -Si, black -NbC particles; green -TiC particles; blue -MnS particles

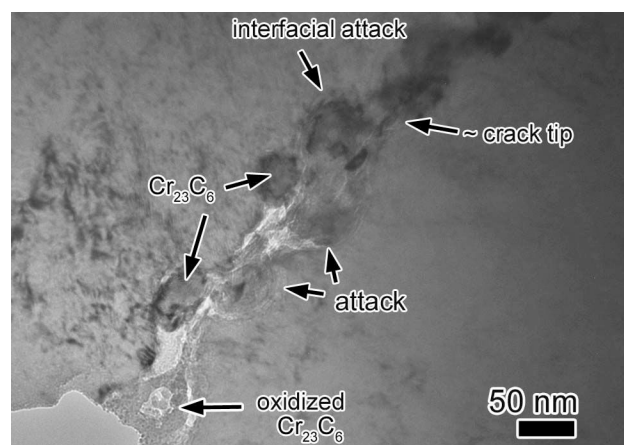
TEM examinations of the North Anna weld samples focused mainly on the crack tips and leading grain boundaries. As illustrated by Figures 8 and 9, the

cracking occurred along grain boundaries that were decorated by closely spaced 30- to 50 nm-diameter Cr-carbide particles and 5- to 10-nm-diameter NbTi carbides.

Figure 8. Crack tip region in North Anna 2 TEM sample. Shows degraded carbide particles behind crack tip and interfacial attack along the particle interfaces at the tip.

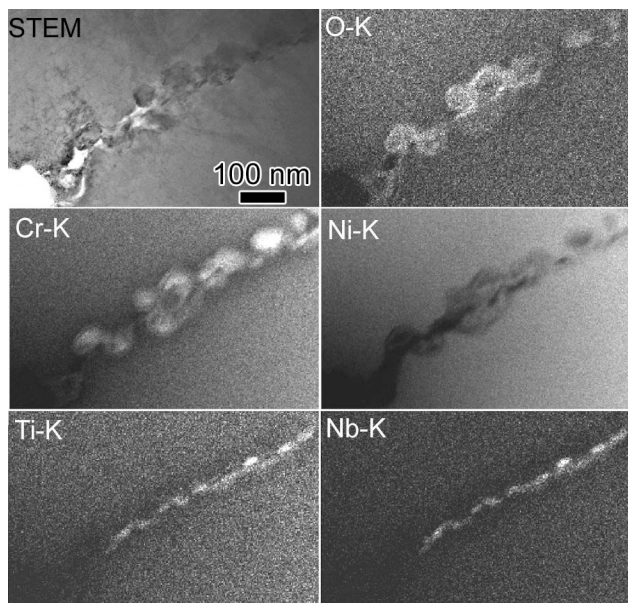
Electron diffraction analyses identified the Cr carbides as cubic Cr_{23}C_6 and the NbTi carbides as cubic MC. The STEM/EDS maps in Figure 9 distinguish the particles by their compositions, and illustrate how the particles become interfacially attacked, convert to oxide, and begin to dissolve in the crack. For descriptive purposes, the leading edge of the oxidation along the attacked grain boundaries and particle interfaces is referred to as the crack tip.

Interfacial attack around the Cr carbide particles near the crack tip can be seen by comparing the particle images in the O-K and Cr-K maps. Due to partial spectral superposition of Cr-L and O-K x-rays, the oxidized and unoxidized regions of the particles both appear highlighted on the O-K map. The oxidized shells around the attacked particles appear brighter than the unoxidized cores. In the Cr-K map, the oxidized shells appear fainter than the cores.

Another effect shown by the EDS maps is the apparent dissolution of the carbide particles in the crack, starting at short distances behind the crack tip. This is indicated by a decrease in particle intensities on the Cr, Nb and Ti maps.

Figure 9. STEM EDS maps of crack tip area in previous figure. Shows interfacial attack (oxidation along particle interfaces at the tip) and apparent dissolution of degraded carbides in crack.

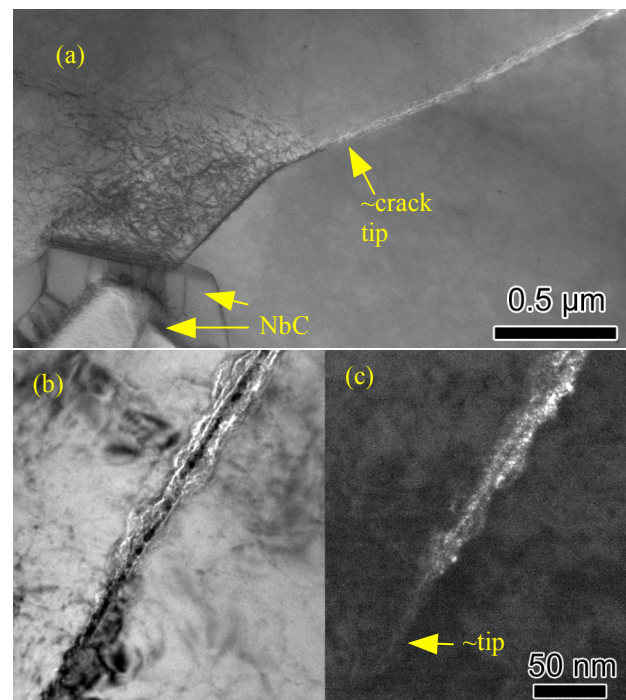
In another tip example, shown in Figure 10, the crack ended along a locally straight section of grain boundary near a cluster of μm -size NbC particles. The tangled dislocation structure of the weld metal can be seen in a strongly diffracting region just head of the crack tip. Higher magnification brightfield and oxide darkfield images of the tip region in Figure 10(b) and (c) highlight the interfacial attack around fine IG carbide particles, and polycrystalline MO-type oxide in the crack. The exact location of the tip is hard to pinpoint, but is best judged from the oxide darkfield image. The oxide narrowed to less than 10 nm wide at the tip.

Figure 10. Second crack tip in North Anna weld sample. (a) STEM overview with grain boundary on edge. (b) TEM brightfield and (c) MO oxide darkfield images.

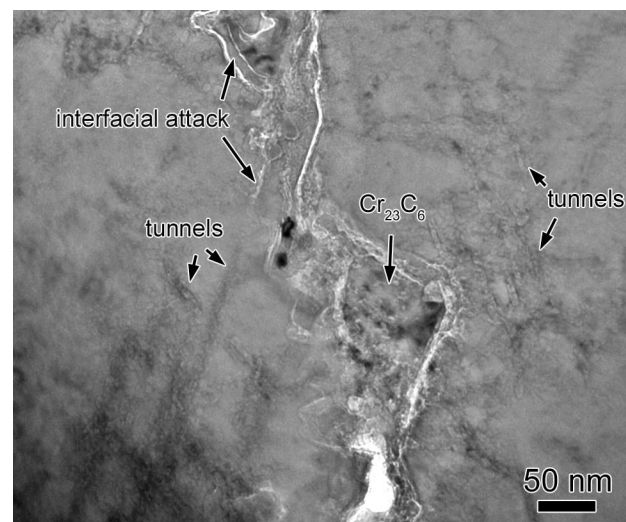
Crack regions near the tips were filled with corrosion products oxide and remnants of the attacked IG carbides. Figure 11 shows an example of the attacked and degraded structures ~ 0.5 to 1 μm behind the crack tip. Degraded microstructures in this area included the oxide corrosion products and remnants of the attacked IG carbide particles in the crack, and filamentary corrosion tunnels in the adjacent metal. ATEM analyses indicated a complex set of corrosion products in these structures. Although further analyses would be needed to identify all the oxide phases in this area, diffraction analyses identified polycrystalline cubic MO-structure oxide as the main corrosion product in the cracks. The oxidized shells around altered Cr-carbide particles were tentatively identified as Cr_2O_3 .

Figure 11. Degraded microstructures near crack tip in North Anna weld. Shows interfacially attacked carbides in crack, and oxide-filled 'tunnels' formed along dislocations in the adjacent metal.

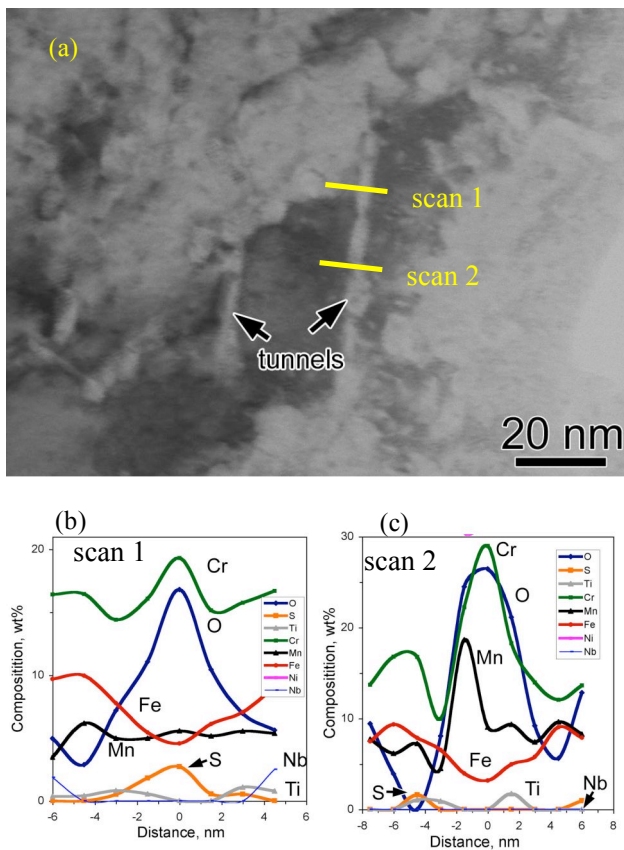
Figure 12 shows the results of fine-probe EDS line scans taken across the corrosion tunnels. The composition profiles indicated Cr and Mn enrichment of the spinel crystallites in the tunnels. Scans taken along tunnels (results not shown) indicated that the tunnel structures consisted of the Cr-Mn-rich spinel crystallites separated by Ni-rich metal. As also indicated by the results, the tunnels also contained spots of concentrated S (up to ~ 2 wt.% through the local foil thickness). High S concentrations were also observed previously in similar corrosion tunnels from the Davis-Besse alloy 182 weld sample. Scans taken across unattacked dislocations ahead of the tunnels showed no detectable segregation of any alloying elements such as Nb or Ti, nor any S segregation at the dislocation cores.

Figure 12. EDS composition profiles across corrosion 'tunnels' near crack tip in North Anna 2 alloy 182 weld sample.

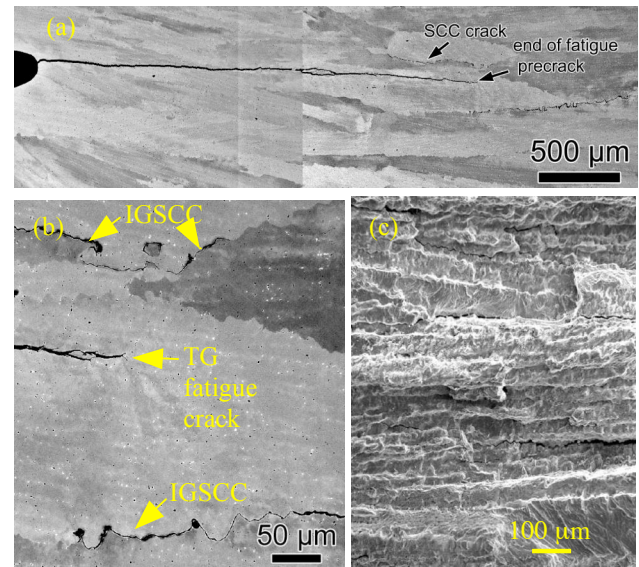
This alloy 182 crack-growth test in simulated PWR primary water produced disconnected-appearing SCC cracks along approximately parallel grain boundaries. As shown by an overview image of the cross-sectioned test sample in Figure 13(a), the cracks occurred parallel to the elongated grain structure of the weld. A higher

magnification view of the tip region in Figure 13(b) shows that initial IGSCC during final crack transitioning and at constant K was highly non-uniform. The cracks had the serpentine appearance of grain boundaries produced by dendrite impingement during weld solidification. Despite the discontinuous-connected appearance of the cracks in cross section, the presence of oxide corrosion products throughout them indicated that the cracks had been completely penetrated by high-temperature water. The post-test SCC fracture surface shown in Figure 13(c) also suggests that the grain boundary where cracking occurred also corresponded to a dendrite boundary.

Figure 13. Cracks in Alloy 182 weld from test in simulated PWR primary water. (a) Low-magnification SEM/BSE overview of metallographic section. (b) TG to IG crack transition region. (c) IG fracture surface illustrating interdendritic fracture morphology.

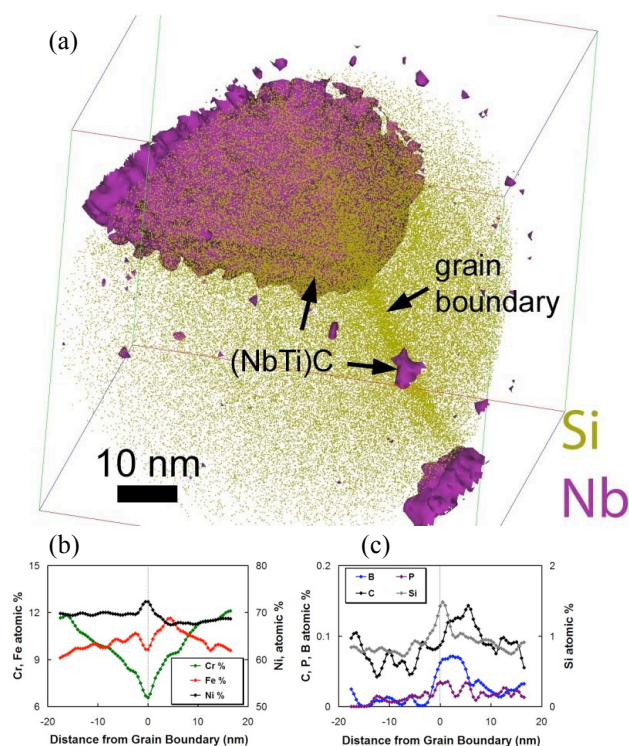
Additional grain boundary characterization has been performed by APT analysis to further probe for evidence of segregation, including light elements such as B and C. This was a pioneering effort that has only yielded preliminary results. As shown by results given in Figure 14, the APT method revealed minor segregation of Si, B, P and C on the grain boundaries. The data reconstruction given at the top of the figure illustrates the Si segregation along a grain boundary between carbide particles. As further shown by reconstructed line profiles at the lower part of this figure, the Si reached ~ 1.5 at% at the boundary, vs. $\sim 0.8\%$ in the matrix. Boron, C and P were also enriched at the grain boundary, although their maximum concentrations were less than 0.15 at%. No other significant impurity segregation was found. Of the major elements, the results indicated strong local Cr depletion at the boundary, at least in this limited analysis.

Figure 14. APT analysis of grain boundary in Alloy 182 weld. (a) Data reconstruction for Si and Nb, showing grain boundary on edge and Si segregated along boundary. (b,c) Reconstructed line profiles for major and minor elements.

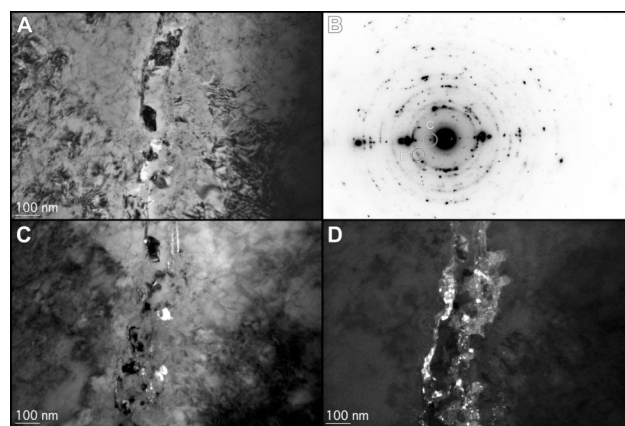
TEM observations of the PWR test sample described here again focus primarily on the crack tip regions. Where the cracks narrowed near their tips, they appeared filled with polycrystalline corrosion product oxides. Diffraction analyses of these regions indicated that both spinel and NiO-type oxides were present, as well as remnants of the original and altered (Nb,Ti)C and Cr_{23}C_6 carbides from the original bulk grain boundaries. Figure

Figure 15. Analysis of oxide-filled crack region near tip in alloy 182 PWR crack growth specimen. (a) TEM brightfield (a), (b) selected area diffraction pattern, (c) darkfield image taken with a reflection from Cr_{23}C_6 , and (d) darkfield image highlighting polycrystalline MO-structure oxide.

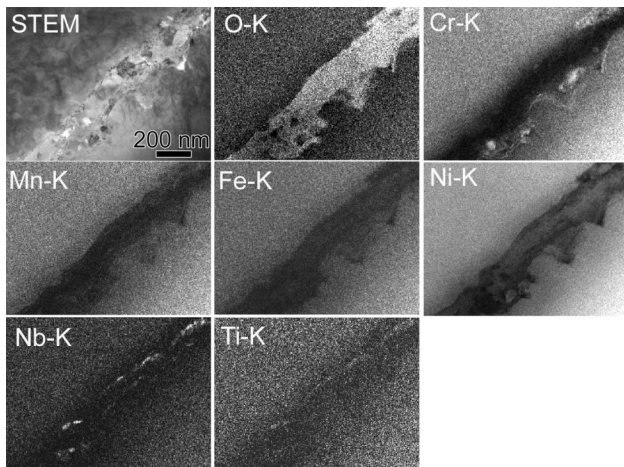
15 shows an example of these structures with selective darkfield imaging used to identify the phases. STEM/EDS maps of the same crack area, in Figure 16, show the extent of the oxide and indicate the partial dissolution of Cr carbide and MC particles in the crack. Remnants of the intergranular MC carbides appear as small Nb and Ti-rich spots at the crack walls.

Figure 16. STEM EDS maps of oxide-filled crack region near crack tip in PWR-water test sample

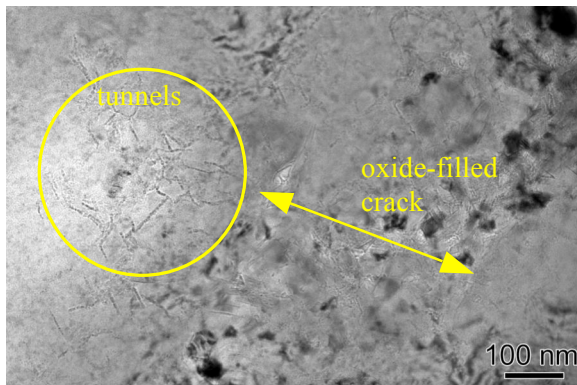
Other TEM images taken under under- or overfocus conditions revealed corrosion tunnels in the metal, similar to those observed along crack walls in all the PWR service samples. The tunnels are shown by an overfocus image in Figure 17. Diffraction patterns from the areas with tunnels showed the presence of oriented spinel oxide in the metal, and darkfield images taken with spinel reflections also showed that the 5- to 8 nm-wide 'tunnels' were filled with this oxide. The observation of these corrosion tunnels in the weld sample that was tested in PWR primary water indicated that the test reproduced one of the most distinctive features of the cracks from service samples. As was also found in the service samples, the tunnels formed in the cracks behind the attack fronts.

Figure 17. Corrosion tunnels in the metal along an oxide-filled crack in PWR-water test sample. Tunnels appear dark in overfocus image.

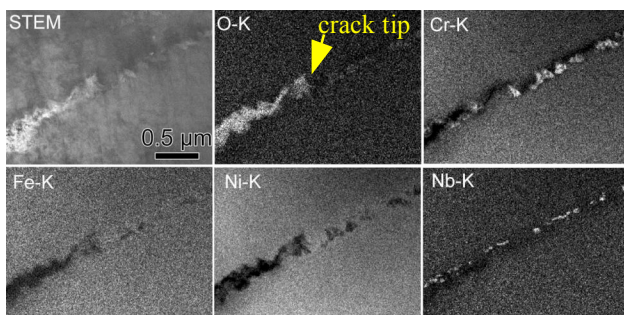
High-resolution STEM/EDS maps in Figure 18 show one of the crack tip regions. The tip location where the oxide ended can be identified from the O-K map. The Cr-K map shows Cr_{23}C_6 particles along the grain boundary ahead of the crack tip, and partially attacked particles immediately after the tip. The MC particles in this region did not show any indication of corrosion attack. Also, no significantly elevated Ni concentrations appeared in the metal ahead of the cracks, in contrast to observations in other Ni-base alloys (such as alloy 600) with cracks produced in PWR water environments. In the grain boundary region ahead of the crack tip in Figure 18, the Cr map highlights the Cr_{23}C_6 particles and indicates a strong depletion of Cr near the particles.

Figure 18. EDS maps of crack-tip region in CT012. Crack appears somewhat inclined in these images.

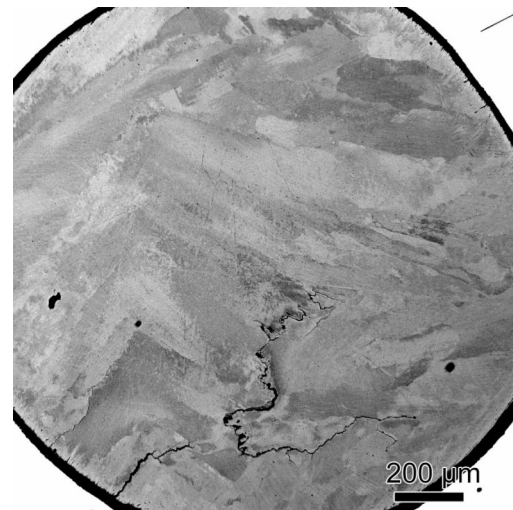
Multiple SCC cracks occurred along the weld grain boundaries ahead of the transgranular precrack in the test sample. Often, these cracks appeared significantly deviated from the direction of the fatigue precrack. Figure 19 illustrates the weld grain structure and typically wavy appearance of the IGSCC cracks that formed near the end of the test. The mottled crystallographic contrast in this image is characteristic of highly strained metal.

Figure 19. Alloy 182 TEM sample from SCC test in oxidizing BWR water plus sulfate.

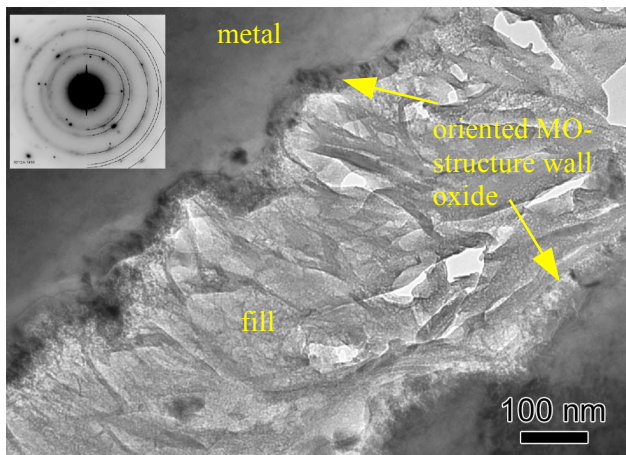
TEM observations of narrow cracks in the BWR-water test sample generally showed uniform, 30- to 50-nm-thick films of oriented cubic MO-type oxide along the walls and polycrystalline corrosion product with a sheet-like structure filling the crack centers. Figure 20 shows the wall oxide films and crack-fill material. Diffraction ring patterns from the crack-fill product did not match any standard patterns in the EDD database (the closest match was to the cubic MO structure). Most likely, this product was an unidentified hydroxide.

Figure 20. Loosely-filled crack in Alloy 182 TEM sample from CG test in BWR water. Inset diffraction ring pattern from fill product approximately matched cubic MO.

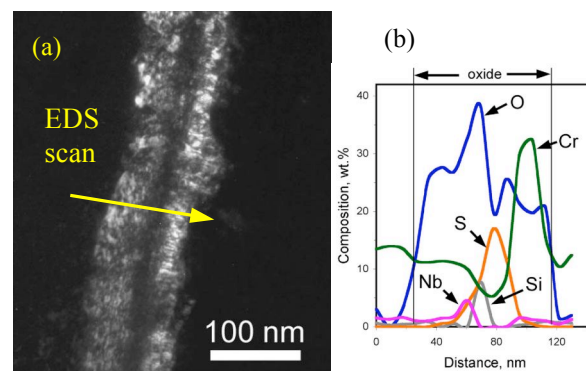
As the cracks narrowed, the oriented wall oxide films became the predominant corrosion product. A narrow band of fine-grained oxide containing high S continued to the crack tips. The crack region shown in Figure 21 contained uniform 30 to 50-nm wide MO-structure films at the walls, and a central layer of nanocracked material. This figure shows a composite MO-darkfield image that was produced by combining oxide darkfield images from both sides of the crack (the images were taken using different MO spots from the diffraction patterns taken at the metal/oxide interfaces of both matrix grains.) Composition profiles across the crack in this area are shown in Figure 21(b). The profiles indicate an asymmetrical crack microstructure with a Cr-rich region at one side corresponding to the location of Cr-carbide particles along the original grain boundary. This, and other profiles obtained from cracks in this sample, suggested that the cracking occurred along one side of the originally carbide-decorated grain boundaries. The profiles in Figure 21 also indicate high S in the material along the crack center, as well as Si and Nb in the central layer. Additionally, the Cr-rich regions along one side of the crack coincided with high O, indicating that the carbides had been at least partially oxidized.

Figure 21. Narrow IG crack in Alloy 182 sample from BWR-water test. (a) Superimposed oxide darkfield images of oriented MO-type oxide films on both sides of crack. (b) Composition profiles from line scan.

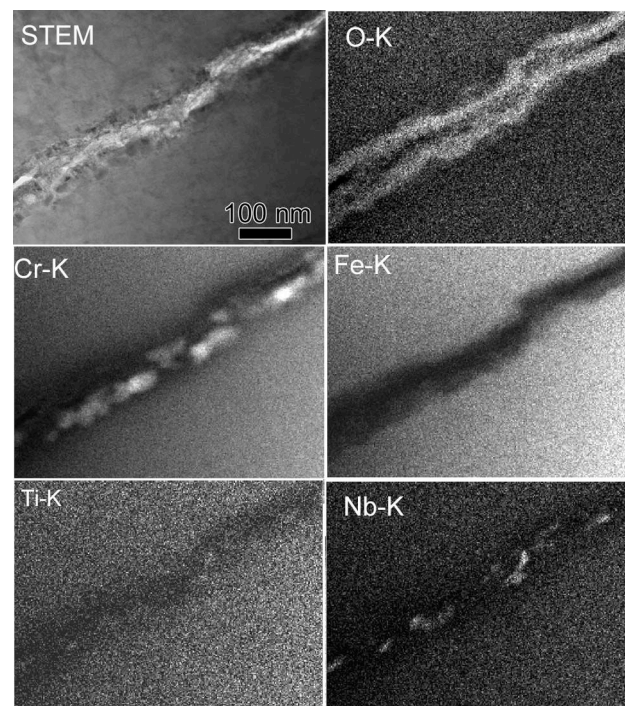
STEM/EDS maps of the same area, given in Figure 22, show the partially oxidized remnants of Cr carbides and smaller MC-type carbides in the narrow crack. The maps also showed losses of Mn, Fe and Ni in the crack.

Figure 22. STEM/EDS maps of near-tip crack in BWR test specimen.

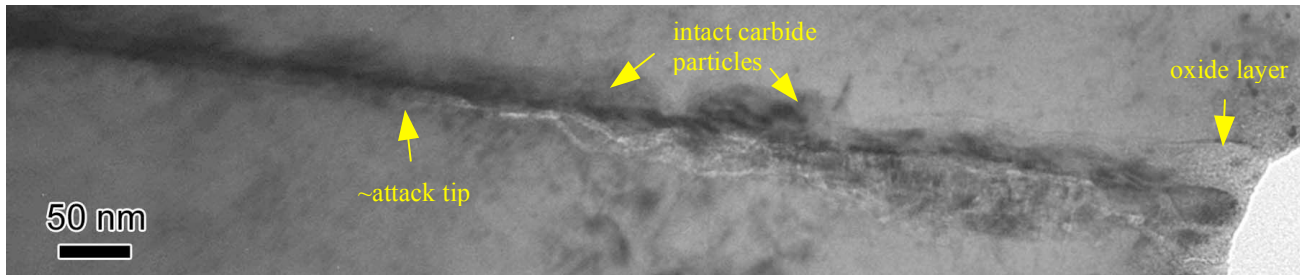
TEM observations of several crack tips in the BWR water test specimen showed the epitaxial MO oxide films along the crack walls tapering very gradually before ending along the carbide-decorated grain boundaries. The epitaxial oxide formation was preceded by one-sided attack along the carbide particle interfaces. This highly localized attack produced 'cracks' only a few nm wide on one side of the carbide particles. Figure 23 shows a tip

example with the image contrast enhanced to improve the crack visibility. It is difficult to tell exactly where the narrow attack ended.

Figure 23. Crack tip in BWR-water test sample. TEM brightfield image enhanced to show asymmetrical attack at tip.

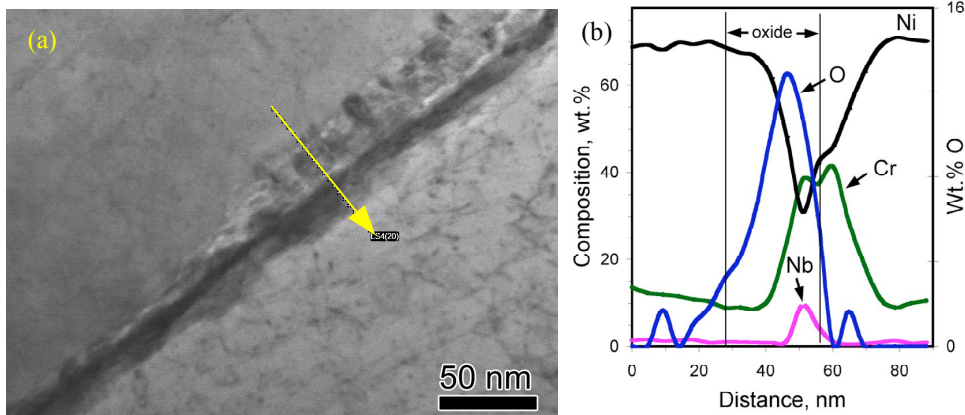
Another crack-tip example in Figure 24 includes results of a fine-probe EDS line scan analysis across the oxidized zone at the tip. The oxide narrowed to a few nm just ahead of where the line scan was made. Composition profiles in this figure show the oxide region displaced to one side of a Cr carbide particle. This analysis also detected Nb and Ti (not plotted) apparently from an MC particle. However, no S was detected this close to the crack tips.

Figure 24. Line scan EDS analysis near crack tip in BWR-water test specimen. (a) STEM image. Arrow indicates scan location. Composition profile in (b) shows asymmetrical oxide formation at IG carbide particle.
